## International Journal of Surgery Case Reports

# A technique to remove a stable all-polyethylene cemented acetabular liner in revision hip arthroplasty: A case report

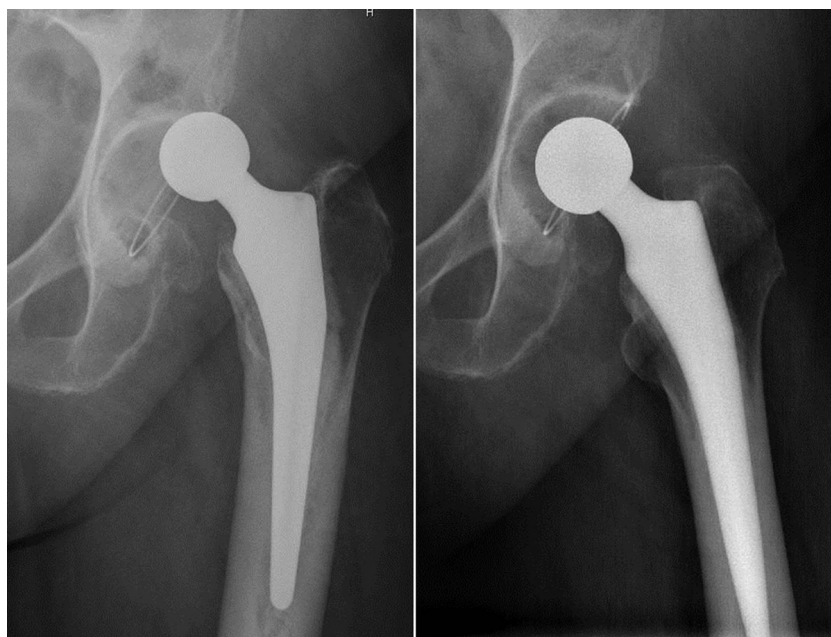
A 74-year-old woman underwent a revision hip surgery for the treatment of a recurrent dislocation of a cemented total hip arthroplasty (eight dislocations), by malposition of the acetabular component (Fig. 1).

**Fig. 1.** Anteroposterior radiographs of the left hip showing a dislocation of a cemented total hip arthroplasty with a stable acetabular component, at follow-up period of 4 years. After closed reduction, it was possible to observe the malposition of the acetabular component: low anteversion of the liner with an inclination angle of 57 degrees.

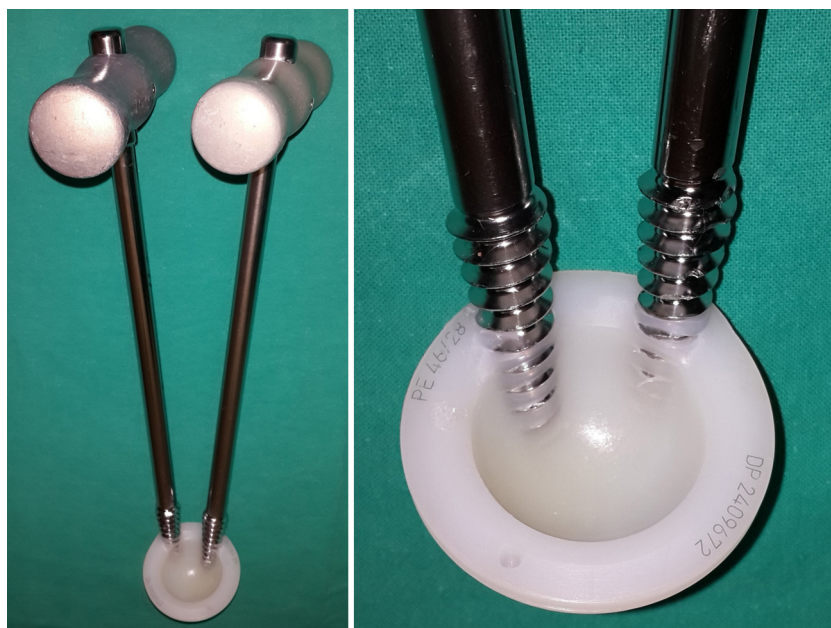
**Fig. 2.** The extraction of the liner was carried out by two cork-screws firmly screwed, as far as possible, in the rim of the all-polyethylene cemented acetabular liner.

The all-polyethylene acetabular liner was perforated with a 4.5 mm drill, and two cork-screws were firmly screwed in the rim as far as possible, in order to extrude the liner from the cement mantle, and to create also fissures into the cement (Fig. 2). Manual torsional shear forces were carried out, which led to a total disruption of the polyethylene liner at the polyethylene-cement interface. Adequate manual torsional shear forces were carried out, which led to the disruption of the polyethylene liner at the cement-polyethylene interface, with no technical difficulties. The polyethylene cup was removed with ease. Using cement-splitting osteotomes, the cement mantle was removed in a piecemeal fashion and the cemented plugs were carefully curetted out. A roof reinforcement ring and a cemented cup of UHMW polyethylene were implanted using the standard technique. The metallic femoral head was changed and the femoral cemented stem was retained. No complications were reported in the perioperative course or during the hospitalization period. At 2 month postoperatively the patient was clinically able to walk without external support.

The cork-screw femoral head extractor is a standard instrument in orthopedic surgery, found in most hip hemi-arthroplasty instrument sets. The cork-screws cause fissures and fractures in the cement mantle. The bone cement (polymethylmethacrylate) is strong in compression, but breaks when twisted [5]. Greater manual control is obtained, facilitating the manipulation of the acetabular component in different directions, tensile forces are applied, and the cup-cemented bond can be disrupted. The cement mantle may be removed in a piecemeal fashion, the host bone is preserved and the risks of complications are minimized. Utilizing simple instrumentations, a new acetabular prosthesis may
