# Acute Mitral Regurgitation due to Ruptured ePTFE Neo-chordae

The Journal of Heart Valve Disease 2007;16:278-281

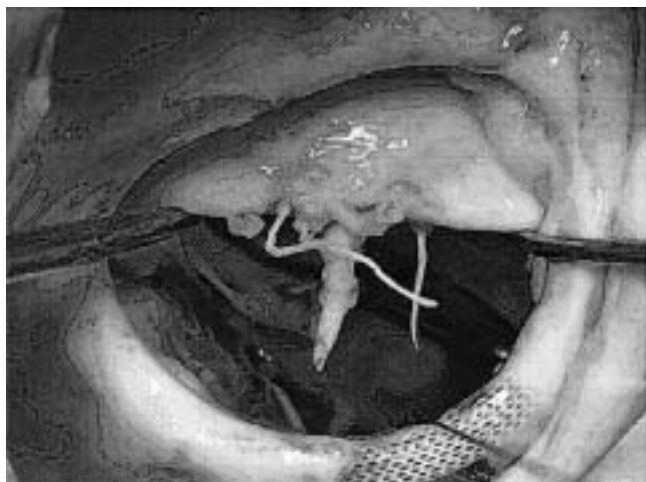
The patient was reoperated in September 2006, whereupon the annuloplasty ring was seen to be well-seated and completely endothelialized, the anterior leaflet mildly thickened but still pliable, and the prolapsed segments to be similar to the previous surgery (A2, A3). The two pairs of Gore-Tex neo-chordae, which did not appear calcified, were broken at 10-12 mm above the tips of the papillary muscles, which

Figure 1: Intraoperative view of the ruptured ePTFE chordae.

were fibrosed. There were no vegetations present.

Two new pairs of ePTFE chordae were implanted, using the same technique as previously. The mitral valve was tested and found competent, with good coaptation surface and no prolapse. Intraoperative TEE confirmed the valve testing, and there was no residual MR. The patient was discharged home on postoperative day 6, in sinus rhythm, with minimal MR (grade I/IV) on predischarge TTE.

The patient was reoperated in December 2006. The valvular and subvalvular apparatus were thickened, the posterior leaflet was shortened and retracted, and there was one pair of ruptured artificial chordae with an aspect similar to that described in Case #1 (Fig. 1). An attempt to repair the valve was made, but the final result was unsatisfactory and the valve was replaced

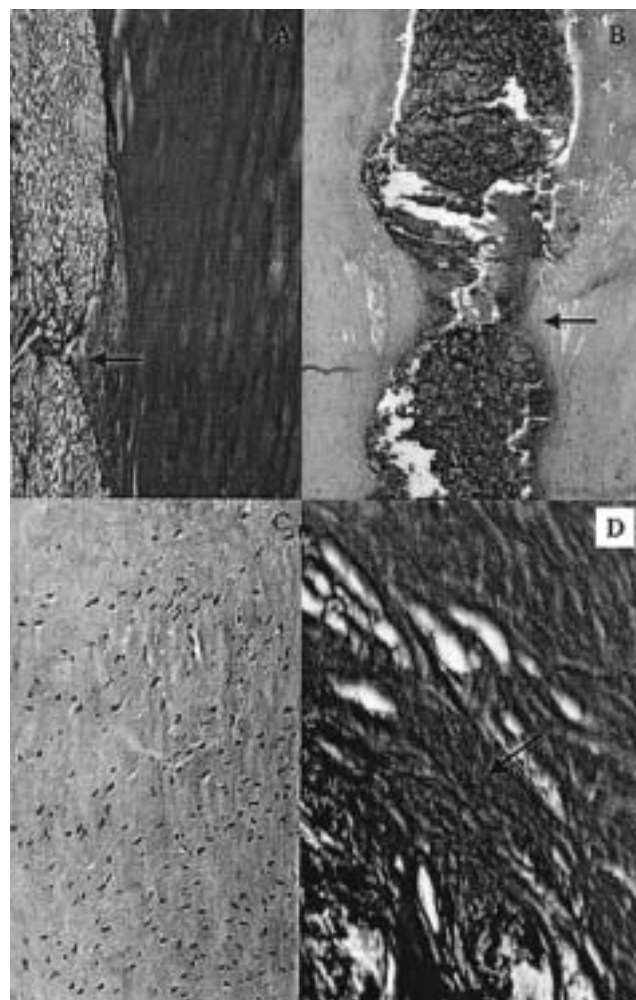
Figure 2: A) The synthetic chordae is weakened by collagen and calcification intermingled in the porous structure (arrow). Note: The clear white areas represent artifactual disruption of tissues and/or loss of tissue during processing. (Hematoxylin & eosin staining; original magnification  $\times 100$ ). B) The formation of cellular connective tissue is clear; the fibroblasts proliferate and produce collagenous and myxoid (bluish) matrix around the chordae. (H&E staining; original magnification  $\times 200$ ). C) The newly formed pannus becomes collagenous around the foreign material, developing a sleeve which causes progressive disruption (arrow) before calcifying (as in (A)). (Periodic acid-Schiff staining; original magnification  $\times 200$ ). D) The collagenous sleeve also has reticulin-Type IV collagen fibers that dissociate the artificial tissue (arrow), indicating a form of repair/scarring. (Gomori staining; original magnification  $\times 400$ ).

Histology of the removed segments of artificial chordae showed calcification and areas of weakness of the synthetic material (Figs. 2 and 3).

*In conclusion*, the use of ePTFE for chordal substitution has represented a significant advance in the technique of mitral valve repair, with excellent reliability and durability. However, surgeons should be made aware of this rare complication when using this material. In the present cases, rupture of the ePTFE chordae occurred at six and 11 years after the initial operation. However, with such generalized use of ePTFE chordae, it is very likely that increasing numbers of these cases will be identified, most likely at centers where this material has been used for many years.

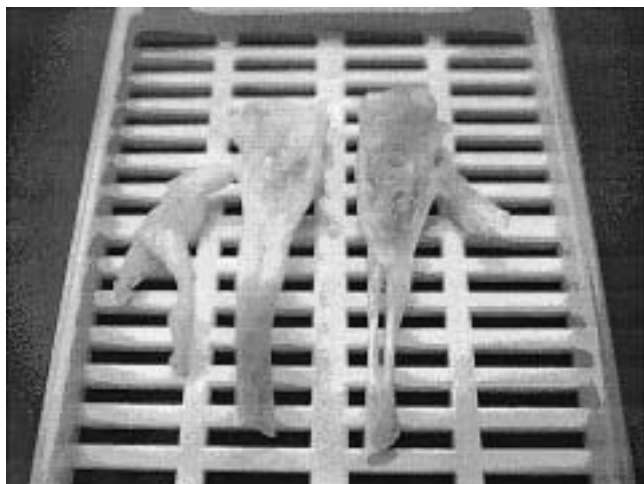
Figure 3: Longitudinally cut sections of the excised chordae. The synthetic material is surrounded by a tough, calcified matrix amid white fibrotic tissue.
