Treatment of Bilateral Recurrent Dislocation of Hip Prosthesis with Malpositioned Well-Fixed Shell: A Case Report*

Fernando Judas[#], Luis Maximino, Francisco Lucas

Orthopedics Department of Coimbra, University Hospital Center, Faculty of Medicine, University of Coimbra, Coimbra, Portugal.
Email: [#]fernandojudas@gmail.com, luismaxfigueiredo@gmail.com, francisco.m.lucas@gmail.com

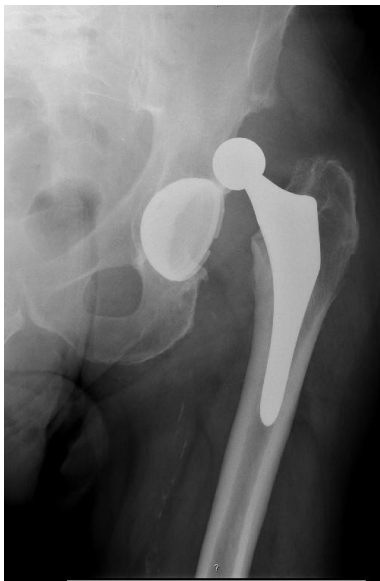
Figure 1. Anteroposterior radiograph of the left hip of a 72-year-old man, made ten years after the initial procedure, showing a posterosuperior dislocation caused by an excessive inclination of the socket. The patient had a history of bilateral recurrent prosthesis dislocation.

After being asymptomatic for three years, recurrent dislocations of the right THA were reported and treated nonoperatively (about ten dislocations). In the other hip three dislocations were noted (Figure 1).

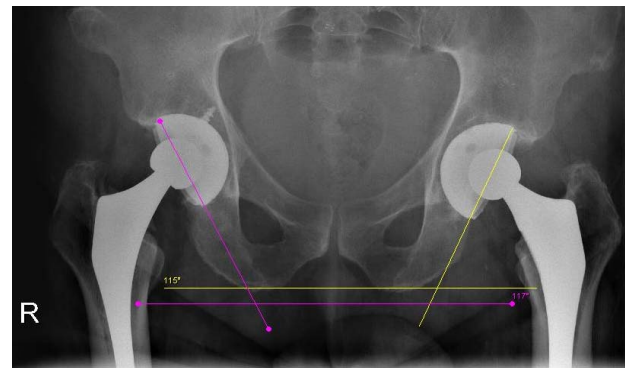
Figure 2. Both acetabular components were well-fixed. An excessive inclination angles of the acetabular components can be observed, 56 degrees in the right hip and 60 degrees in the left.

Apparently, there was a predisposing dislocation mechanism, preoperative roentgenogram showed augmentation of the inclination angle of the acetabular component in both prosthesis, 56 degrees in the right hip and 60 degrees in the left, and absence of radiolucent lines at the bone-socket interfaces (Figure 2). The femoral components were stable. Revision of the acetabular component was the aim of the operation.

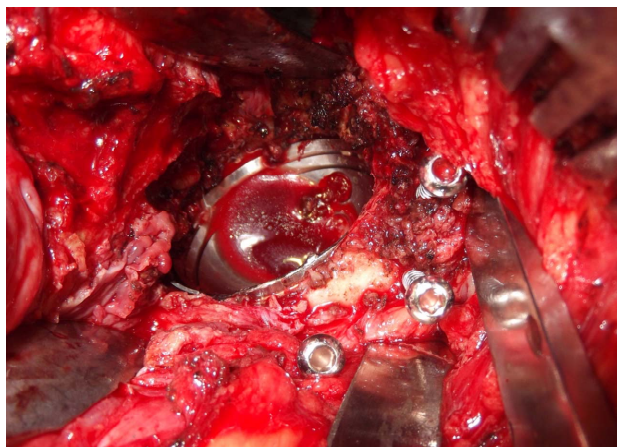
Figure 3. Intraoperative image of the acetabular reconstruction. The original polyethylene liner was removed and 3 cortical screws (4.5 mm) were implanted in the rim of the acetabulum. The existing shell was not replaced.

(4.5 mm) were implanted in the rim of the acetabulum, about one centimeter from the rim and were paralleled superiorly to the ilium. The heads of the screws protrude about 1.5 cm beyond the acetabular bone (**Figure 3**).

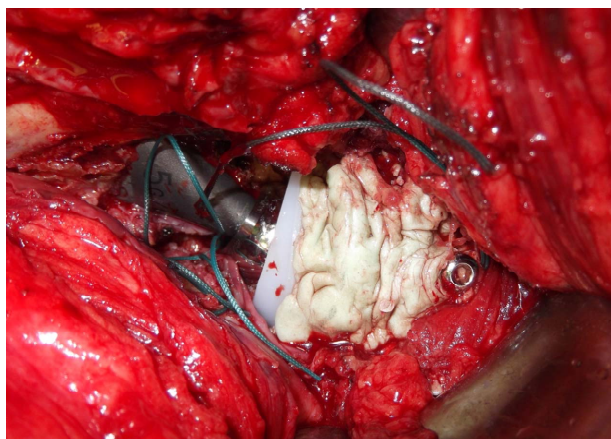
Figure 4. A new undersized cross-linked polyethylene liner was cemented into the shell and properly oriented, about 40 degrees of inclination and 20 degrees of anteversion. A continuous cement mass connected the upper quadrant of the liner surface and the head screws.

The inside area of the shell was cleansed and dried. The bone cement was prepared, and when it was doughy in consistency, it was inserted into the shell and placed over the screws, thus connecting and burying them in the cement mass. Then, the liner was cemented into the existing shell with about 40 degrees of inclination and 20 degrees of anteversion. A continuous cement mass connected the upper quadrant of the liner surface and the head screws (**Figure 4**), and excess cement was removed. The existing 28 mm femoral head was replaced for a new one with the same size.

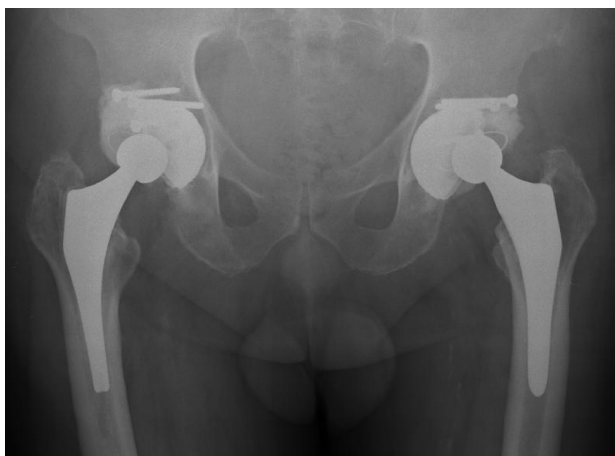
Figure 5. Postoperative radiograph showing the bilateral acetabular reconstruction. An acetabular augmentation (“butée”) composed by a posterosuperior wall of bone cement reinforced by cortical metal screws was created to augment the strength of the surgical reconstruction and to prevent dislocation.

Postoperatively no complications occurred such as deep or superficial infection or deep vein thrombosis and the patient was recommended to bear weight on the joint as soon as possible, with crutches for the first six weeks. No further dislocation was noted. At the last clinical control, nineteen months of follow-up for the right hip and thirteen months for the left hip, the anteroposterior radiograph showed stability of the bilateral acetabular reconstruction (**Figure 5**), and the patient was satisfied

surface of the polyethylene liner, to a buttress of cement and to a mechanical weakness of the reconstruction. The liner is cemented into an eccentric position. With the purpose of augment the strength of the surgical reconstruction and to prevent also dislocation, an acetabular augmentation (“butée”) composed by a posterosuperior wall of bone cement reinforced by 3 cortical metal screws was created.
